Borg-Warner Corporation

INGERSOLL KALAMAZOO DIVISION

Project Report SPDIR-25
Contract NOrd 15719 Problem 4

High Strength MBMC #1 Steel Hydrotest
Case Evaluation, Metallurgical Properties
and Machinability

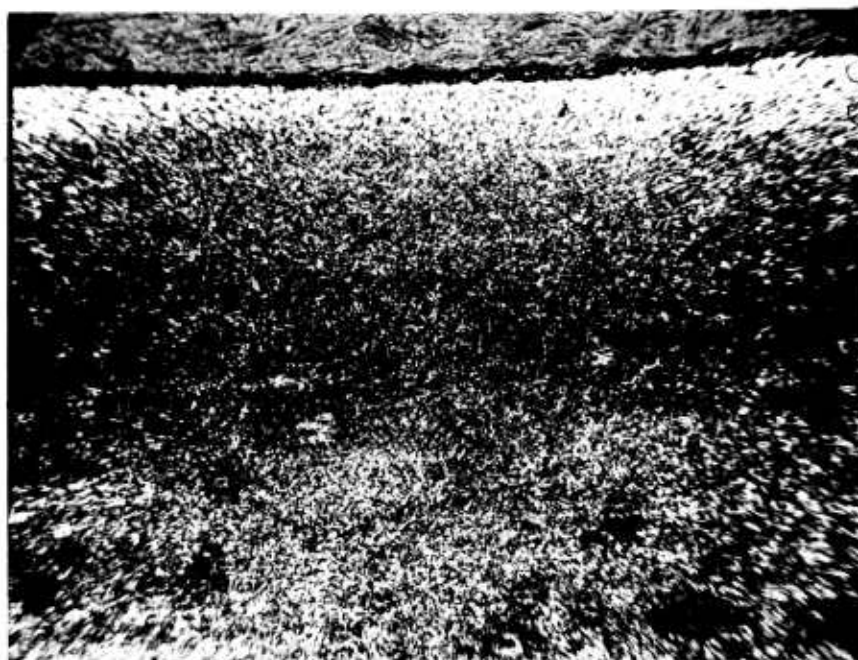
Case F-102. Medium Decarburization.
Magnified 100 Times

Case F-106. Heavy Decarburization.
Magnified 100 Times

Figure 10. Photomicrographs Illustrating Visual Decarburization
on Forged and Spun Cases

Condition III cases were heat treated in a decarburizing atmosphere and the tempering temperatures were varied to determine an optimum tempering temperature for the final evaluation cases. The decarburizing atmosphere was also varied to obtain one case with heavy decarburization and one with medium decarburization for the purpose of selecting a furnace setting for the evaluation cases. Figure 10 shows a photomicrograph illustrating the visual decarburization on cases F-102 (heavy decarb) and F-106 (medium decarb).

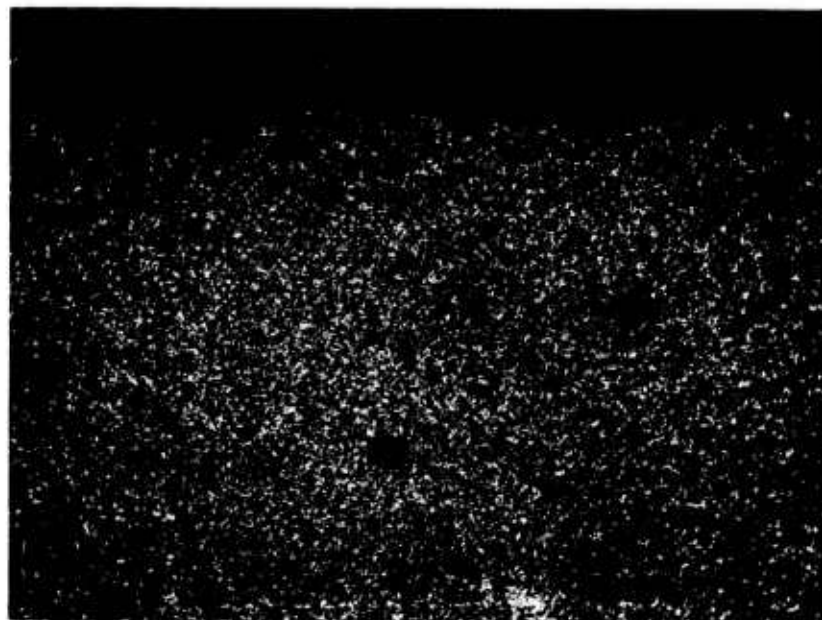
Figure 17. Photomicrograph of Case R-23 Illustrating Lack of Decarburization

Condition I cases were welded entirely with MBMC #1 weld wire and the welds were not dressed in any way. The cases were heat treated at 1600°F for 50 minutes in a neutral atmosphere without a prior descale operation. Figure 17 is a photomicrograph of case R-23 which was typical of all three cases. There was no visual evidence of surface decarburization, however, a microhardness survey revealed a difference in hardness of as much as 5 points R_C from the surface to the core. In all cases the surface hardness was greater than R_C 52 and it was considered that no effective surface decarburization had occurred. In conducting the microhardness survey it was noted

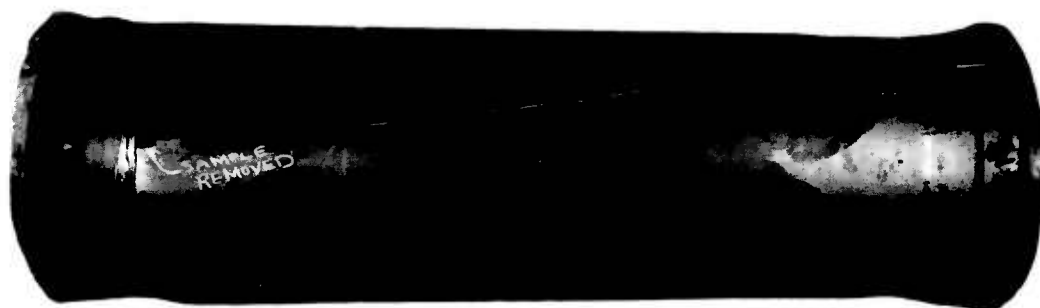
Figure 23. Photographs of Burst Patterns on Cases C-104 and R-31

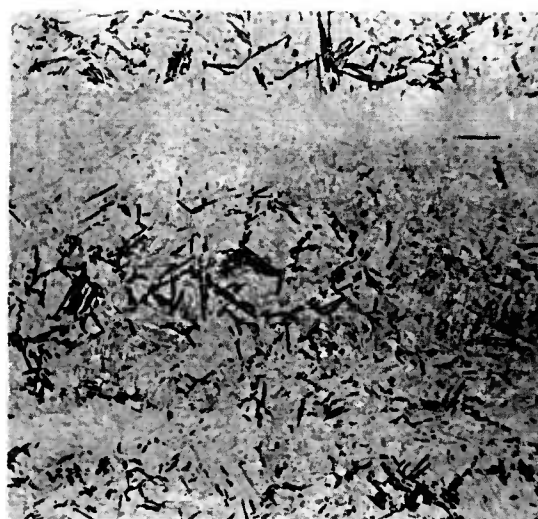
Microstructures of MBMC #1 alloy. austenitized at 1600°F for one hour. transformed as indicated; then water quenched. All photographs at 250X except where noted. All specimens etched in 2% Nital - 2% Picral solution. The photomicrographs illustrate general characteristics of the transformation product rather than any particular stage of transformation.
